NPIC/R-1269/64

PHOTOGRAPHIC INTERPRETATION REPORT

MUNITIONS STORAGE SITE WEST OF SHANG-JAO, CHINA

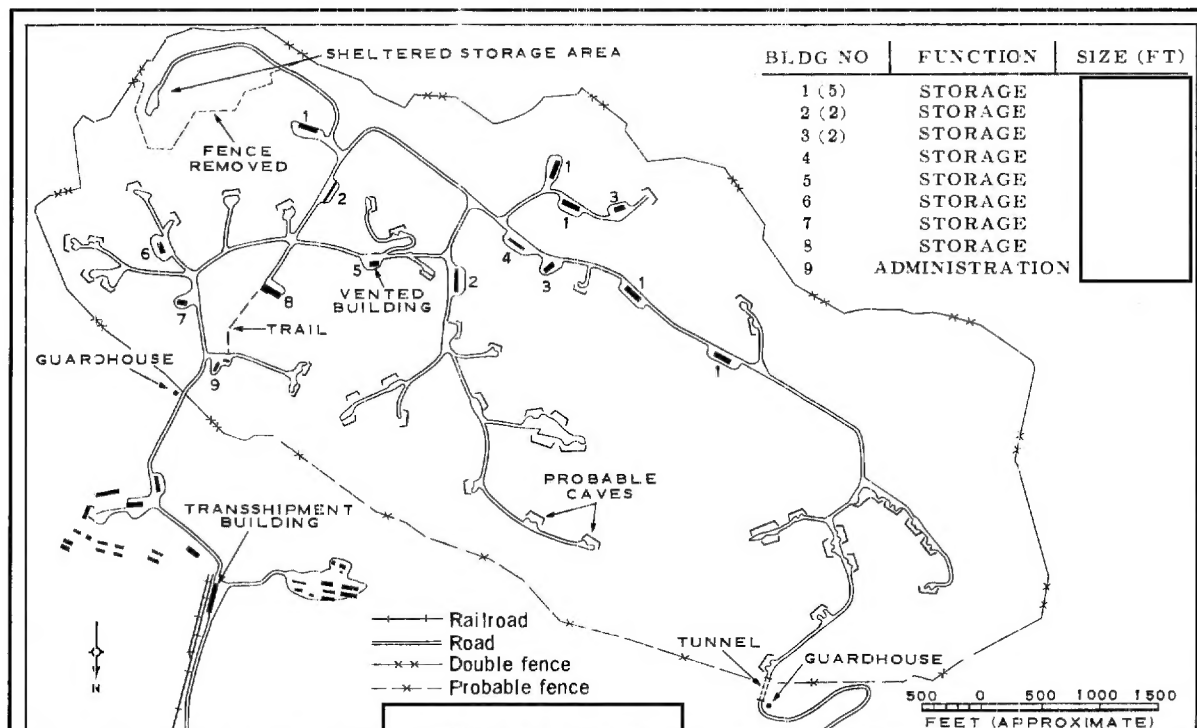
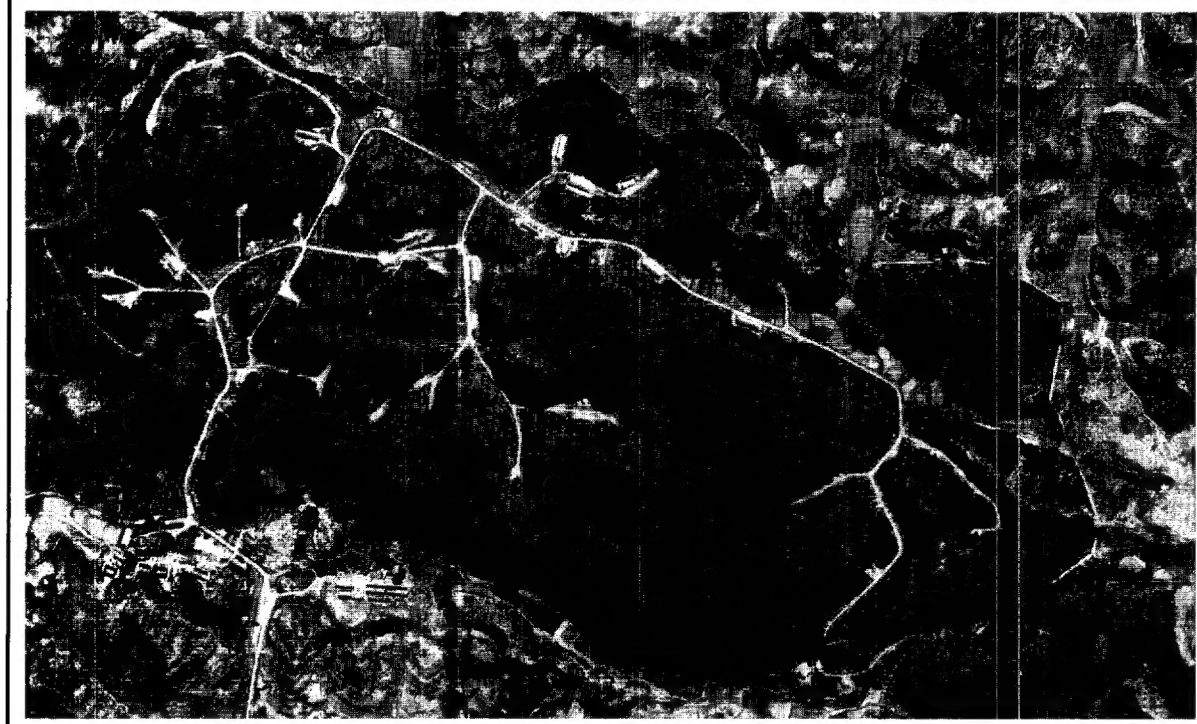
FIGURE 2. MUNITIONS STORAGE SITE WEST OF SHANG-JAO, CHINA

[REDACTED] The site also contains 14 storage buildings of various sizes (Figure 2).

None of the buildings are revetted; however, they are situated in terrain that provides natural blast protection. Adjacent service aprons permit easy access to the buildings. The number of doorways in each building cannot be determined. One storage building (item 5) has a single, low, gable-type roof ventilator (Figure 3).

Security. The site is double fenced around most of its circumference. Shadow precludes identification of security measures on the north side of the site; however, a fence probably extends along the base of the steep cliff that forms a natural barrier along this side. The location of the fences is cleared of vegetation to improve visibility. Guardhouses are at both entrances to the site.

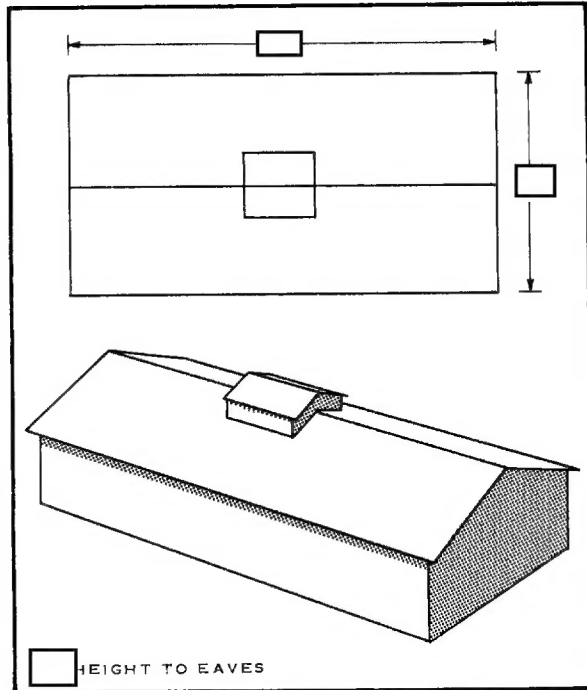
FIGURE 3. PLAN AND PERSPECTIVE VIEWS OF BUILDING 5.
